**Flood Control Project Maintenance
Levee Inspections**
LMA District Cover Sheet
Spring 2011 Levee Inspection Results

Sacramento Maintenance Yard Putah Creek

Levee Inspection Report By Mile - Spring 2011

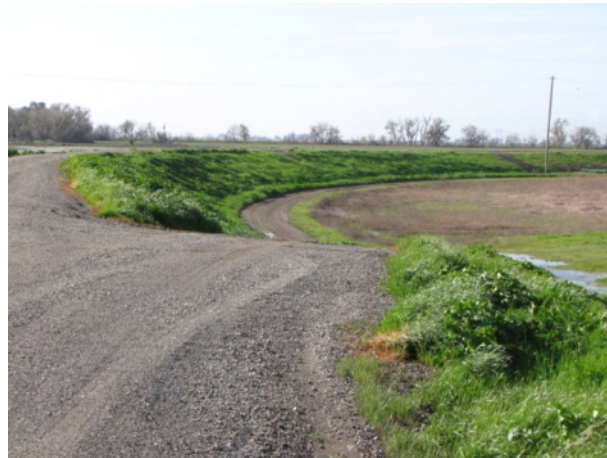
Levee Mile Report Line	1
Start Levee Mile	0.00
End Levee Mile	0.00
Location	Land Side
Category	Earthen Levee
Item	Vegetation

Standing at levee mile 0.00 North levee Putah Creek looking downstream of landside slope. Photo taken 03-22-2011

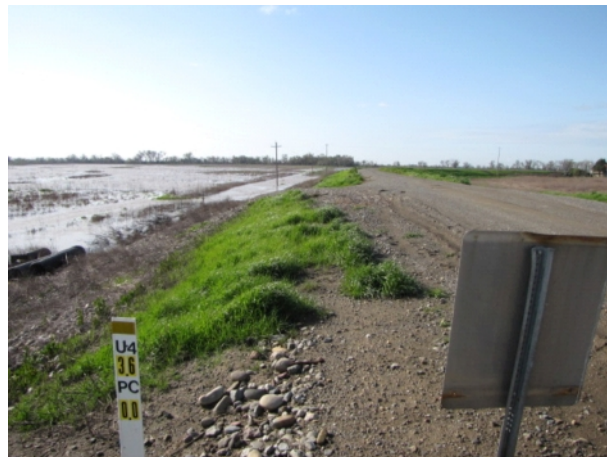
Levee Mile Report Line	2
Start Levee Mile	0.00
End Levee Mile	0.00
Location	Water Side
Category	Earthen Levee
Item	Vegetation

Standing on waterside levee mile 0.00 looking downstream at slope North levee Putah Creek. Photo taken 03-22-2011

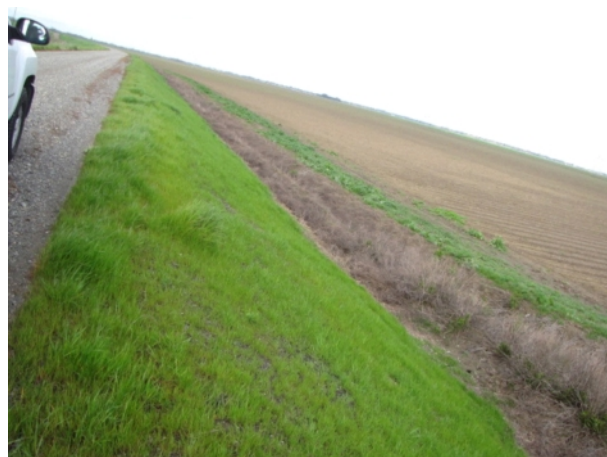
Levee Mile Report Line	8
Start Levee Mile	0.59
End Levee Mile	1.26
Location	Land Side
Category	Earthen Levee
Item	Encroachments

Agriculture Ditch within 10-foot of levee toe levee mile 0.59-1.26 land side Unit 1 Putah Creek. Photo taken 03-22-2011.

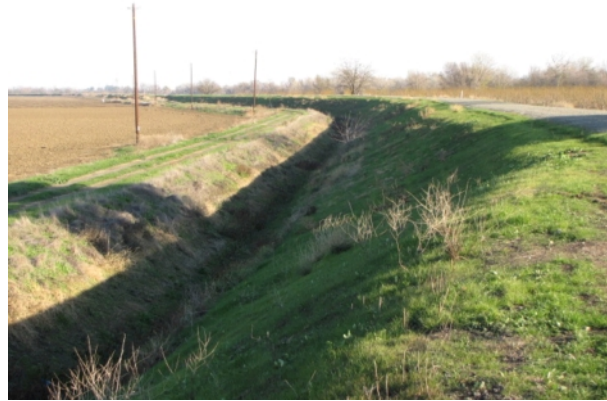
Levee Mile Report Line	10
Start Levee Mile	1.55
End Levee Mile	2.72
Location	Land Side
Category	Earthen Levee
Item	Encroachments

This ditch is located within the 10-foot easement and has been at this location for several years.

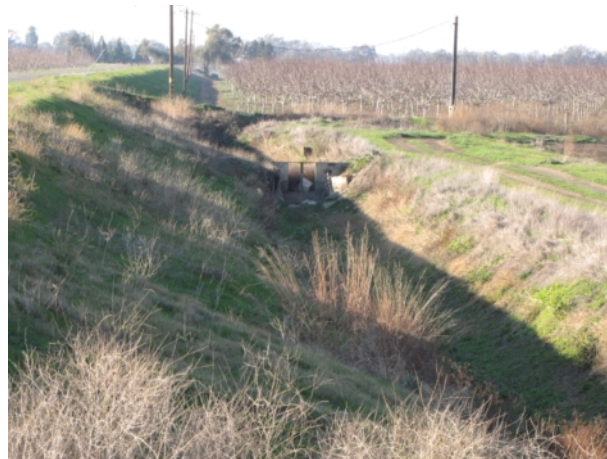
Levee Mile Report Line	10
Start Levee Mile	1.55
End Levee Mile	2.72
Location	Land Side
Category	Earthen Levee
Item	Encroachments

Another view of ditch looking downstream landward.

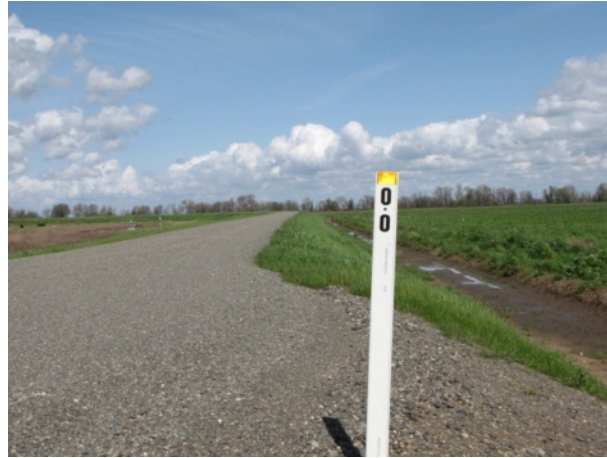
Levee Mile Report Line	1
Start Levee Mile	0.00
End Levee Mile	0.00
Location	Water Side
Category	Earthen Levee
Item	Vegetation
Looking downstream from levee mile 0.00 waterside levee slope of Putah Creek Unit 2. Photo taken 3-22-2011	
phillips_s_20110418_261.jpg

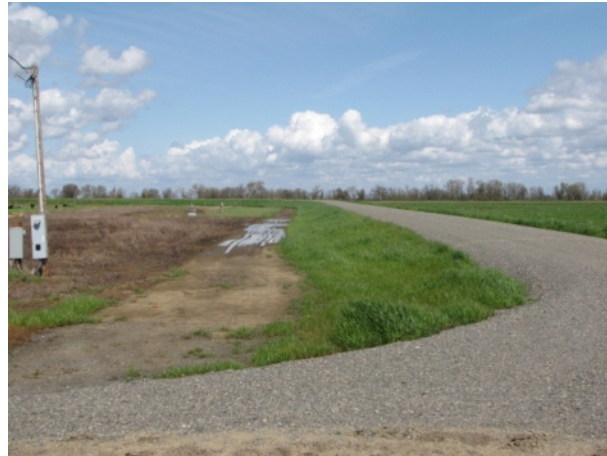
Levee Mile Report Line	2
Start Levee Mile	0.00
End Levee Mile	0.00
Location	Land Side
Category	Earthen Levee
Item	Vegetation
Putah Creek Unit 2 looking downstream from levee mile 0.00. Photo taken 3-22-2011	
phillips_s_20110418_262.jpg

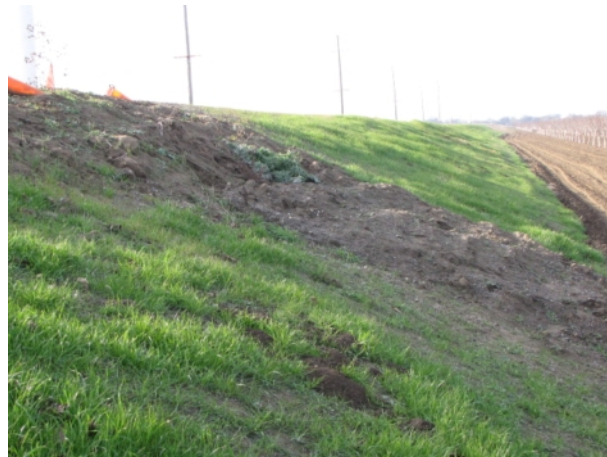
Levee Mile Report Line	6
Start Levee Mile	1.09
End Levee Mile	1.10
Location	Water Side
Category	Earthen Levee
Item	Erosion / Bank Caving
Photo shows partial repair of slope damage.	
phillips_s_20110228_154.jpg

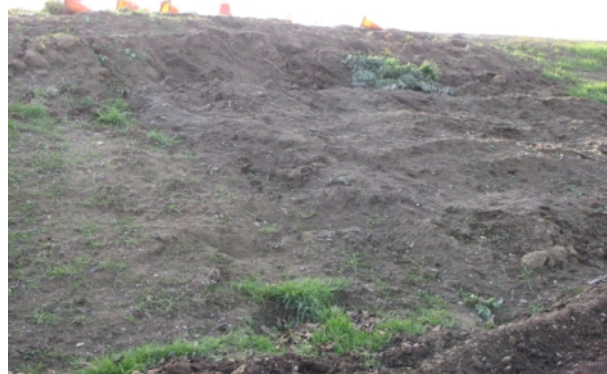
Levee Mile Report Line	6
Start Levee Mile	1.09
End Levee Mile	1.10
Location	Water Side
Category	Earthen Levee
Item	Erosion / Bank Caving

slope damage some repairs made. Proper repair need to be done at this site with compaction test to verify compaction.

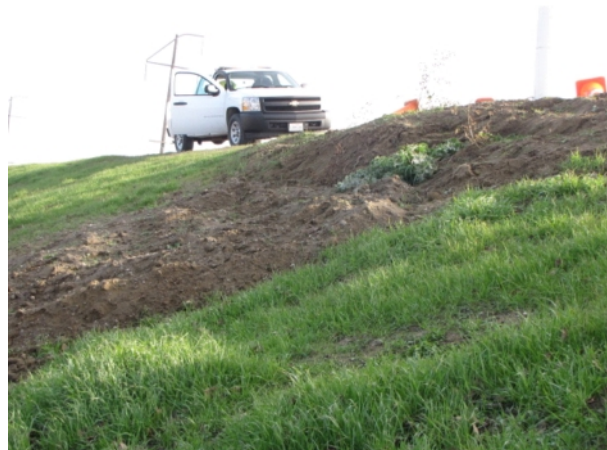
Levee Mile Report Line	6
Start Levee Mile	1.09
End Levee Mile	1.10
Location	Water Side
Category	Earthen Levee
Item	Erosion / Bank Caving

Another view standing on toe of slope looking upstream.
